HAZARDOUS MATERIALS SURVEYS

**NATIONAL OCEANIC & ATMOSPHERIC
ADMINISTRATION**

PRIBILOF FACILITIES

ST. PAUL, ALASKA

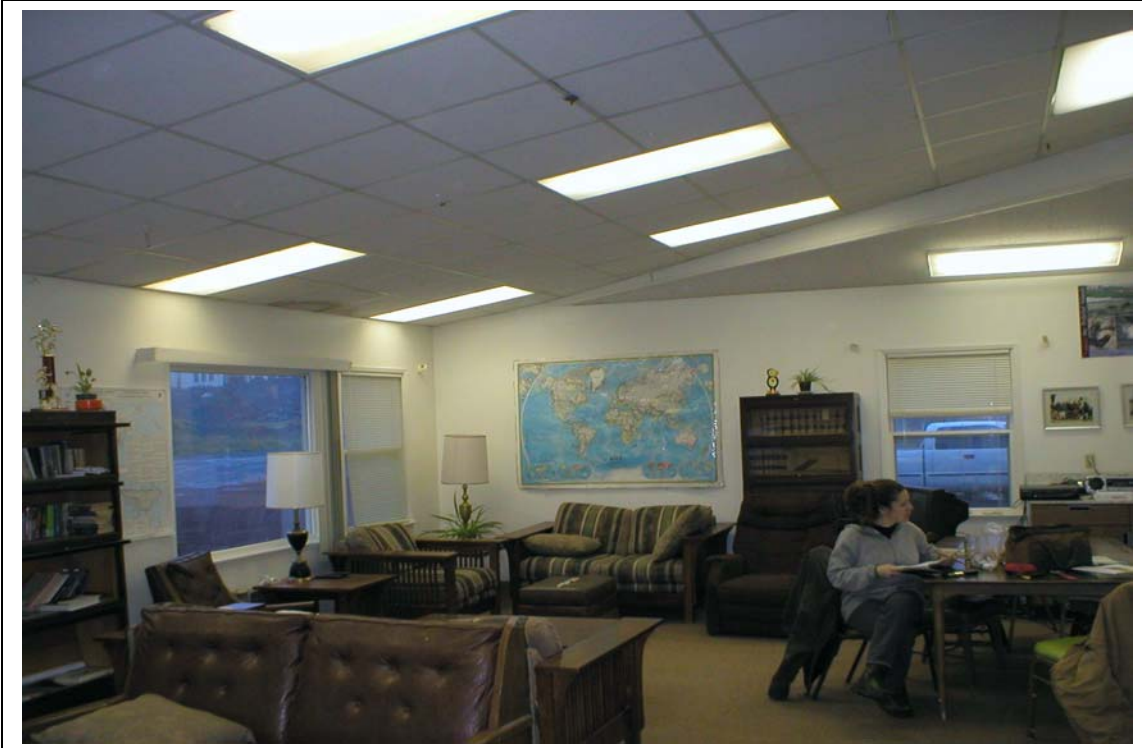
The mastic utilized to hold the 12" x 12" glue-on ceiling tile in place in the Library was found to be asbestos-containing. The material was in good condition and is considered non-friable. There was approximately 150 square feet of this material in the building.

Photo 2: Lower ceiling at back of photo has glued ceiling tiles; brown tile mastic was found to be asbestos containing, Sample A40.

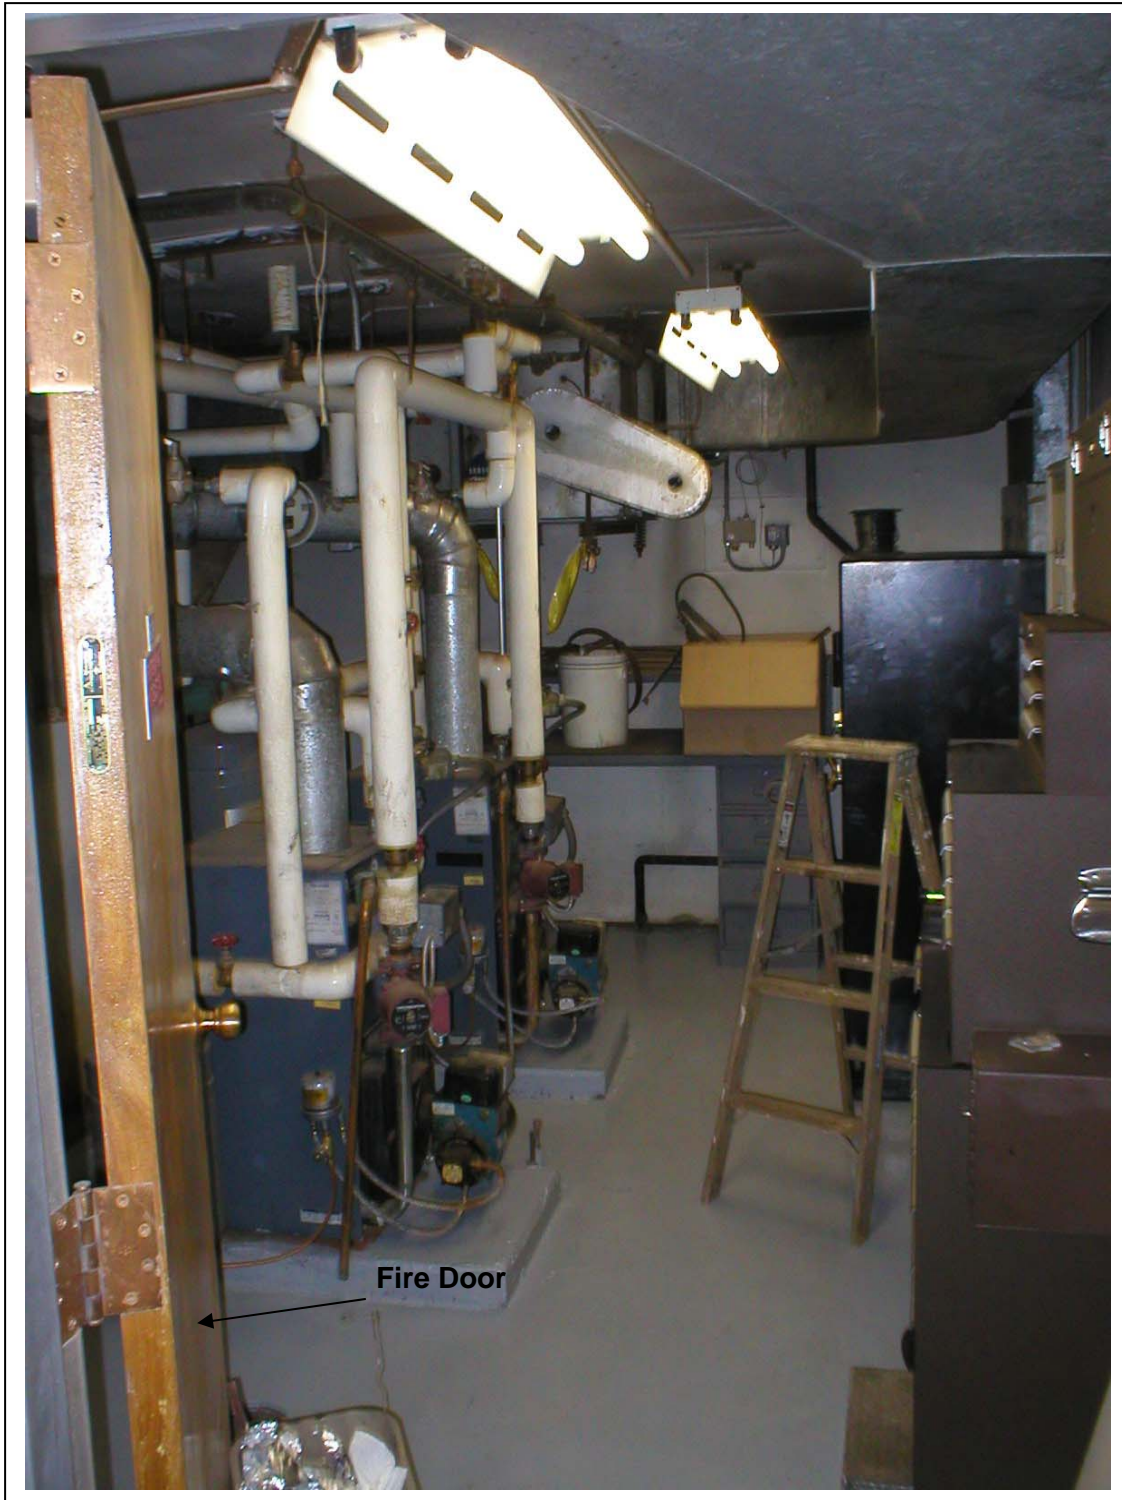
The insulation material inside fire doors was found to be asbestos containing. The material was in good condition and was considered friable. There were two of these doors in the facility, one on the boiler room and one between the library and hallway.

Photo 3: Typical asbestos containing fire door (boiler room), Sample A18.
Photo also shows boiler equipment with assumed asbestos containing gaskets.

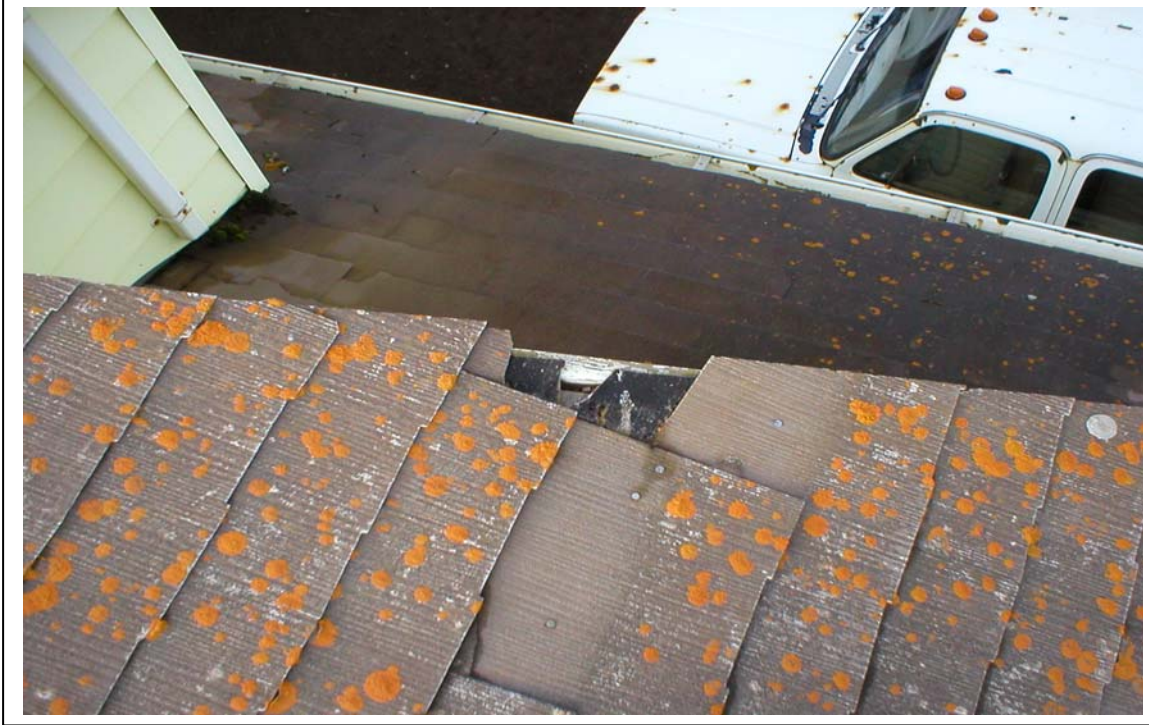
The tarpaper beneath cement shingles on the roof of the facility was found to be asbestos-containing. The material was in fair to good condition and was considered non-friable. There was approximately 6,500 square feet of this material on the building.

The cement shingles on the roof of the facility were found to be asbestos containing. The material was in fair to good condition and was considered non-friable. This material covered approximately 6,500 square feet on the building. No attempt was made to increase the amount of material due to overlap.

Photo 4: Typical asbestos containing cement shingles and roof tarpaper, Samples A43 and A44.

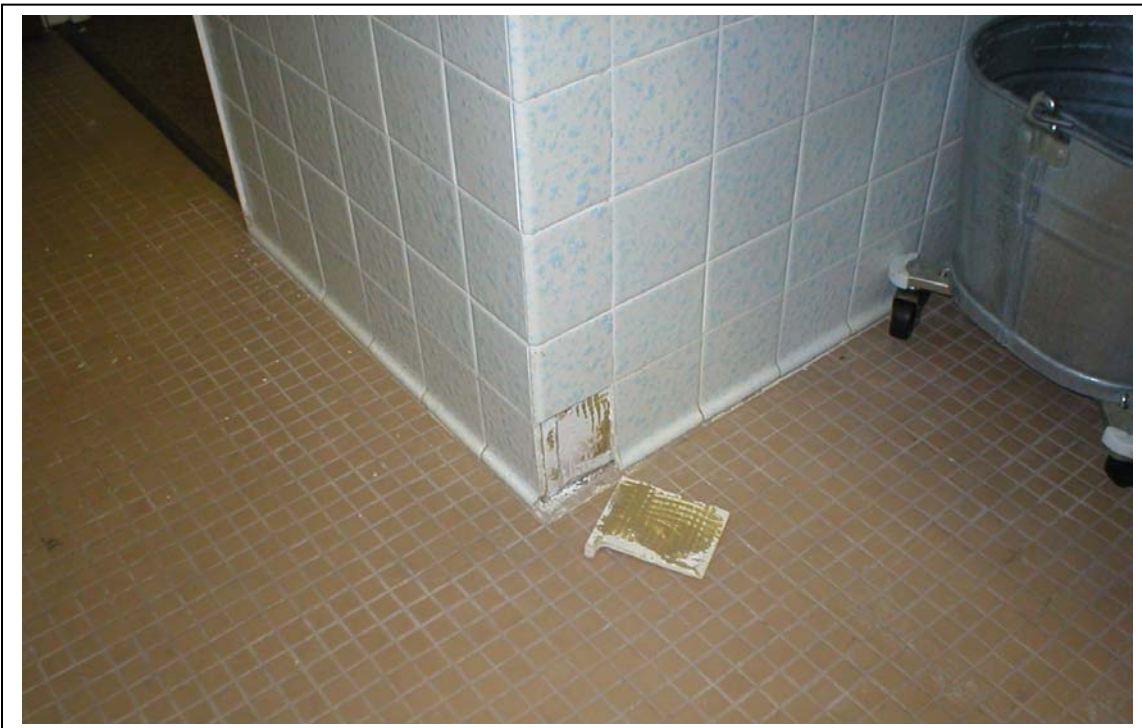
Photo 5: Typical asbestos containing tan ceramic tile mastic, Sample A15.

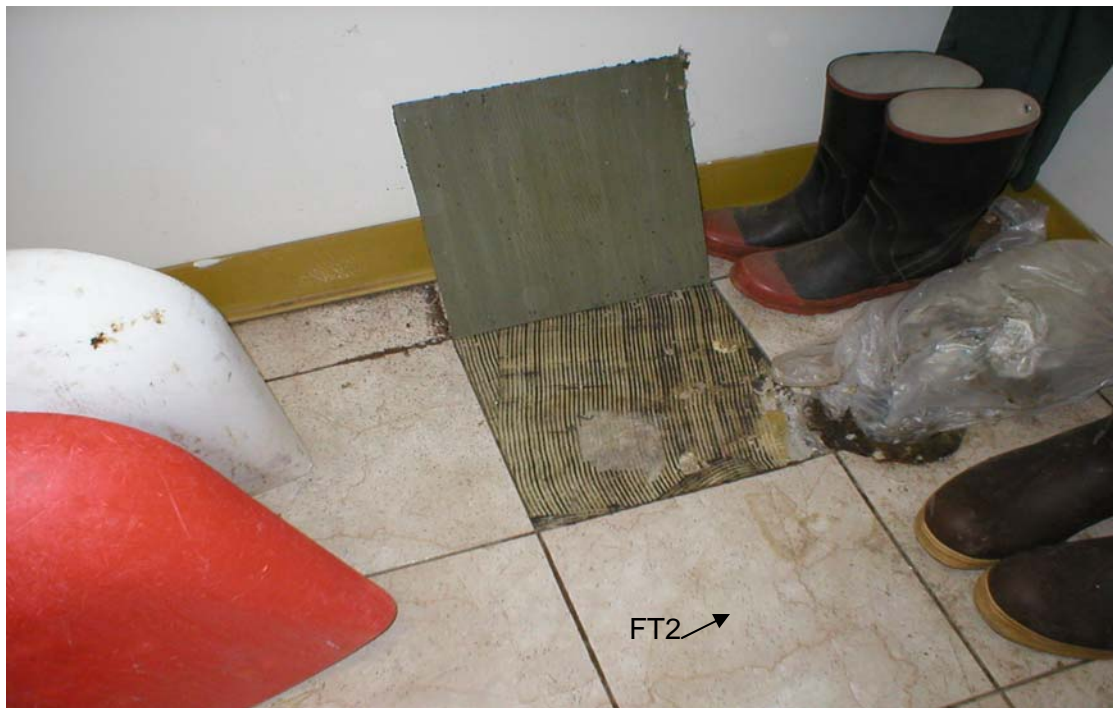
The 12" x 12" marble pattern floor tile was found to be asbestos-containing. This material was self-adhesive and the adhesive was not found to contain asbestos. This material was located in the southern one-third of the building in the corridor, lab and restrooms. The material was in good condition and is considered non-friable. There was approximately 460 square feet of this material in the building.

Photo 2: Asbestos containing marble patterned floor tile (FT2, Sample A18).
Mastic was found to be non-asbestos containing.

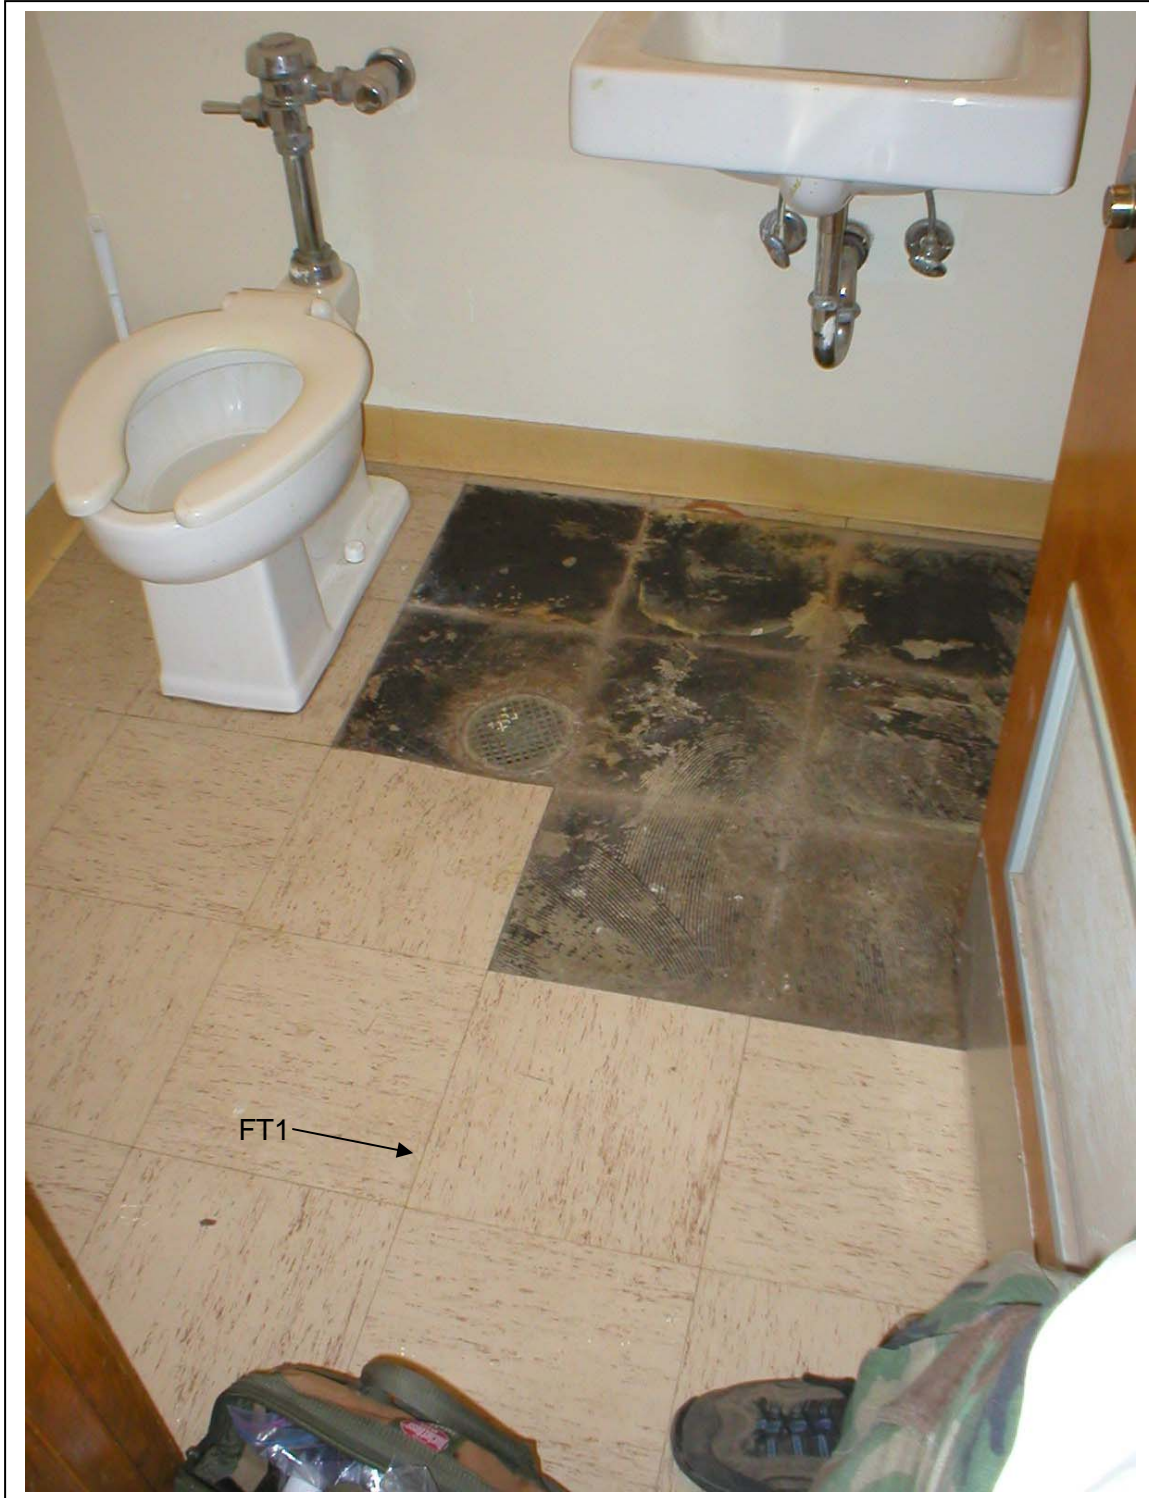
The 12" x 12" tan floor tile with brown streaks (FT-1), as well as the mastic associated with this tile were found to be asbestos-containing. These materials were located in the northern two-thirds of the facility. The material was in fair to good condition and was considered non-friable. There was approximately 1,000 square feet of this tile and mastic in the building.

Photo 3: Asbestos containing floor tile (tan with brown streaks) FT1 (Sample A01). FT1 occurs throughout southern end of building.

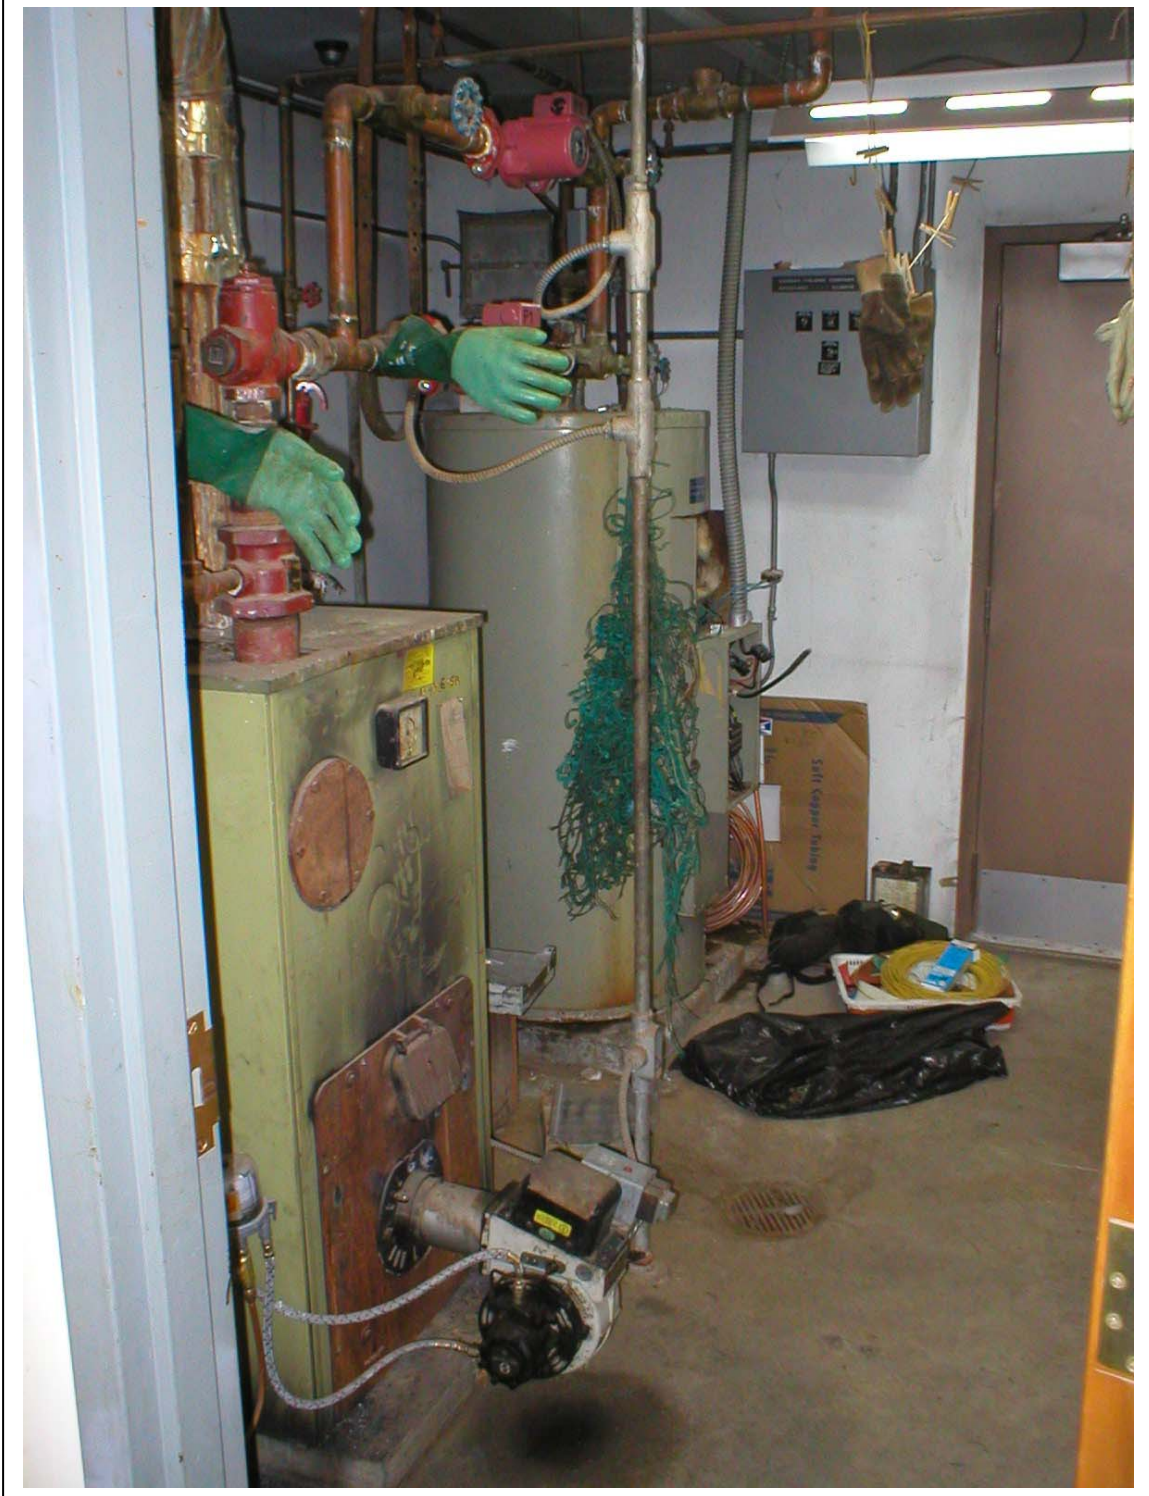
The rope boiler gaskets in the mechanical room ere found to be asbestos containing. The material was in good condition and was considered non-friable.

Photo 4: Boiler room, equipment contains asbestos gaskets (Sample A16); fire door is assumed to be asbestos containing.

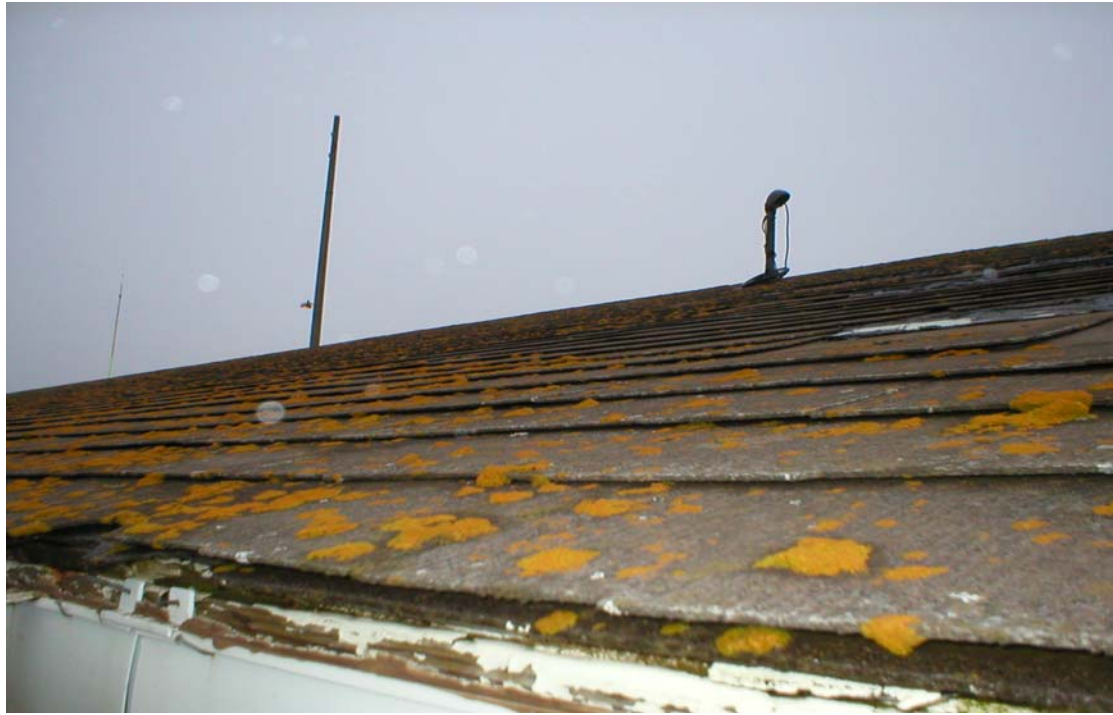
The tarpaper beneath cement shingles on the roof of the facility was found to be

asbestos-containing. The material was in fair to good condition and was considered non-friable. There was approximately 4,250 square feet of this material on the building.

The cement shingles on the roof of the facility were found to be asbestos-containing. The material was in fair to good condition and was considered non-friable. This material covered approximately 4,250 square feet on the building. No attempt was made to increase the amount of material due to overlap.

Photo 5: Asbestos containing cement shingles and roof tarpaper. Samples A27, A28, A29 and A30.

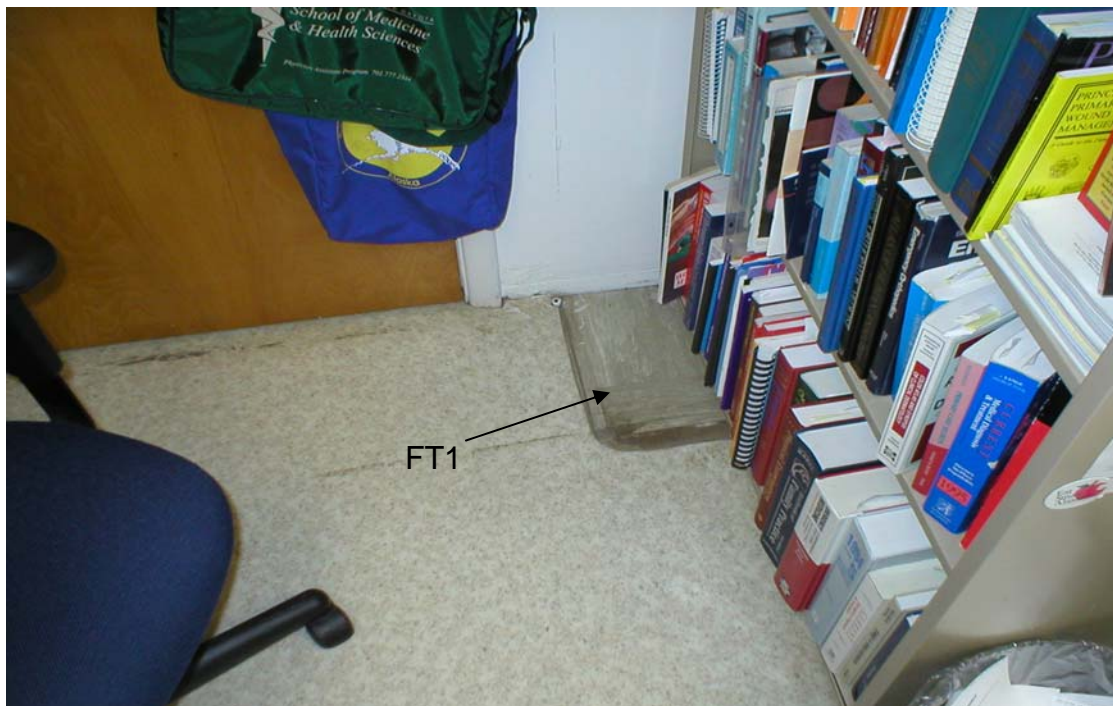
Photo 2: Asbestos containing 9x9 gray floor tiles (FT1), located under non-asbestos containing sheet vinyl in main clinic area. Sample A07.

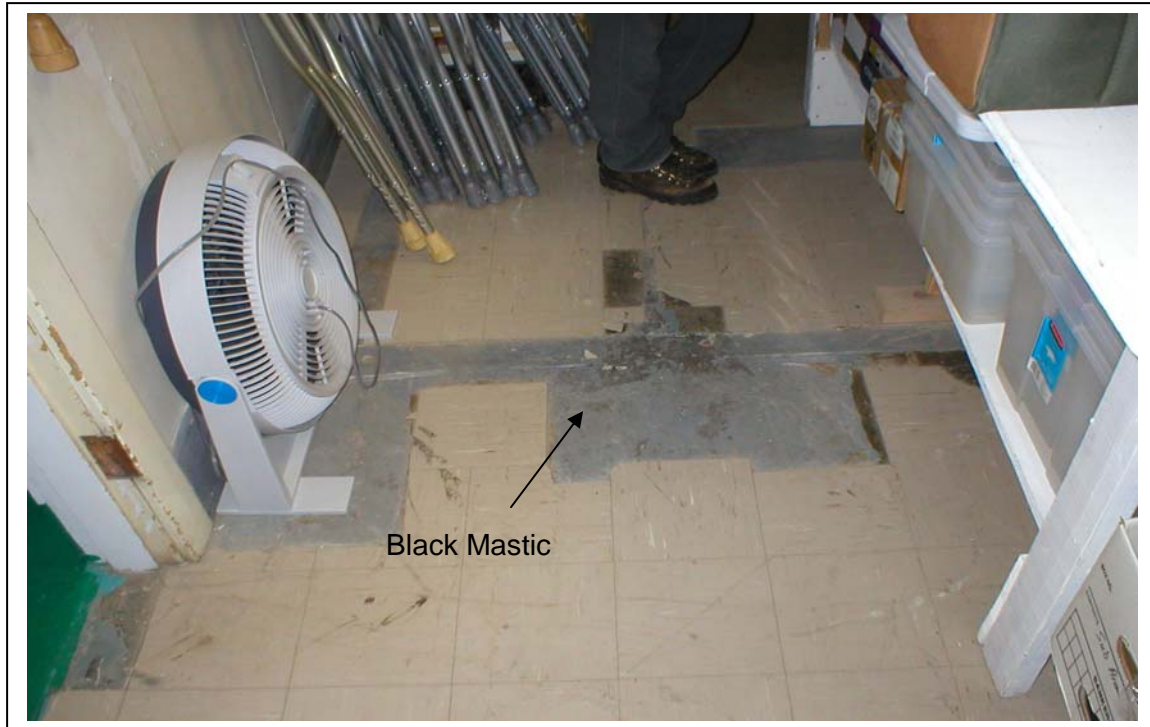
Photo 3: Asbestos containing black floor tile mastic in basement. Sample A45.

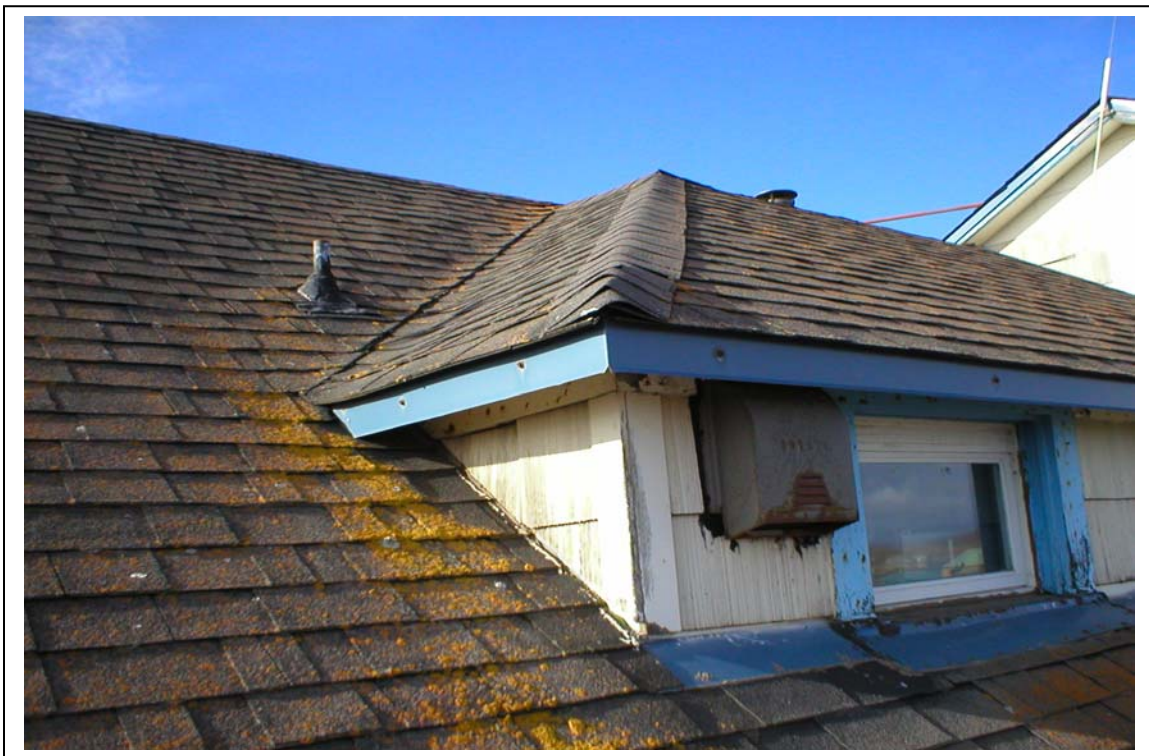
Photo 4: White asbestos containing cement siding shingles on original portions of clinic building. Samples A55 and A57.

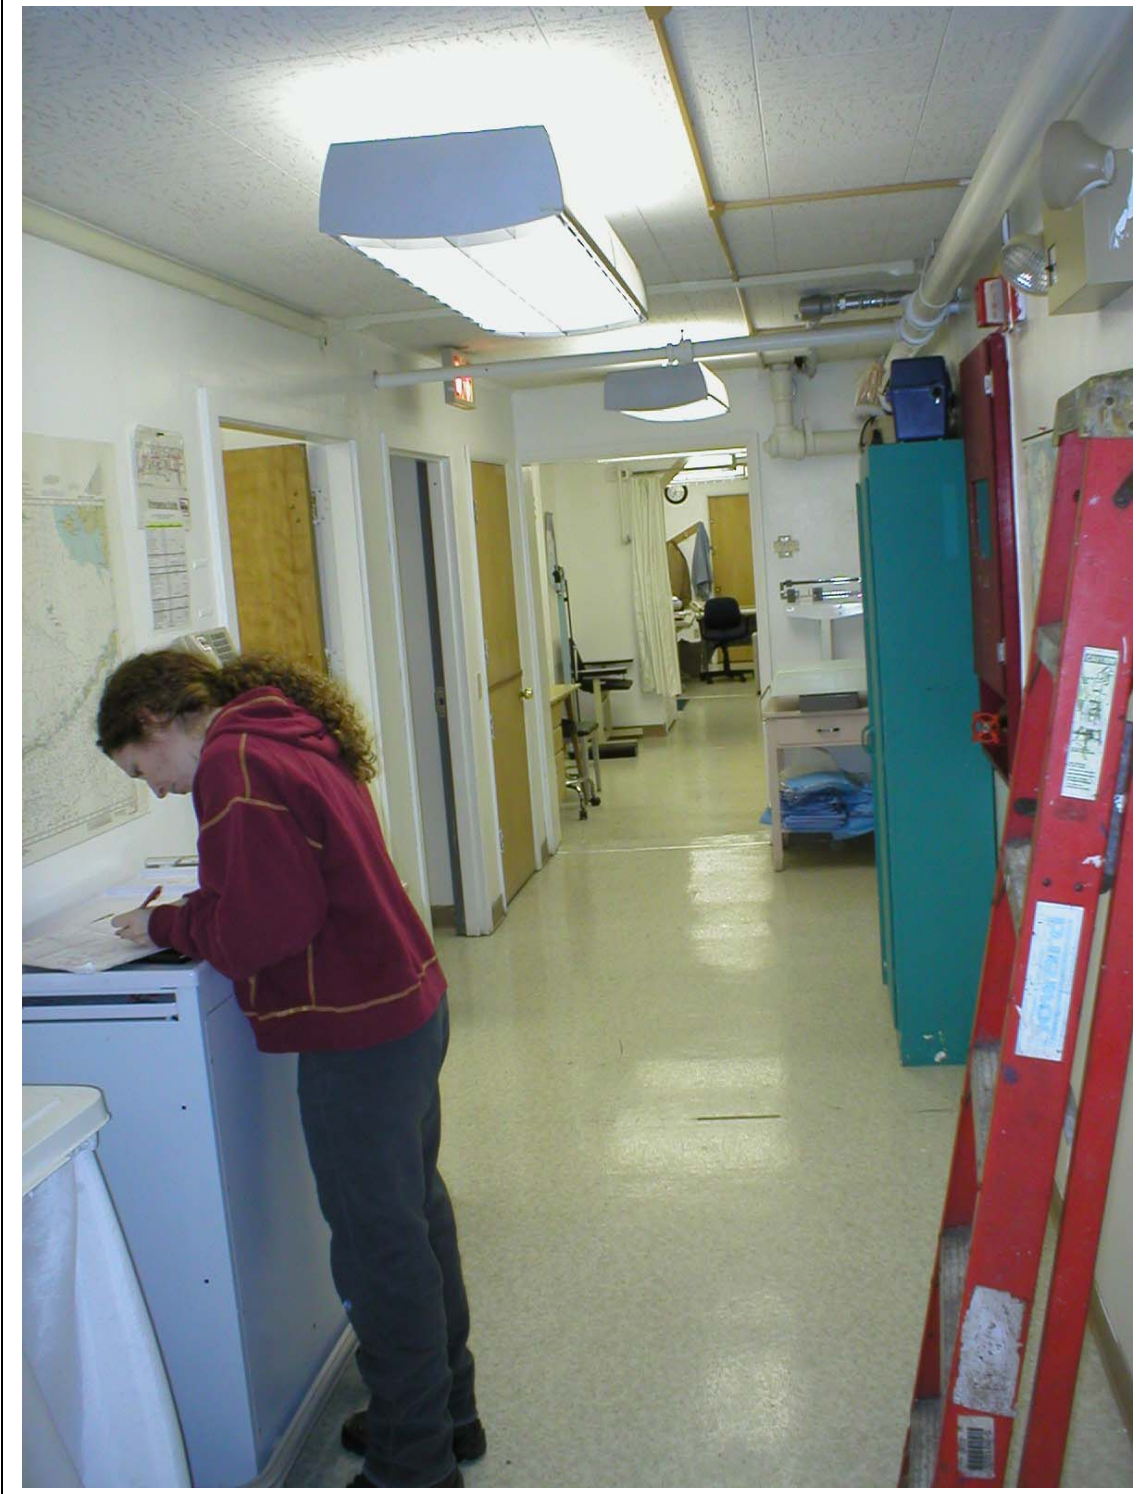
Photo 5: Main clinic area, showing sheet vinyl, under which lies asbestos containing floor tiles (see Photo 2).
